ROCKFORD MUNICIPAL AIRPORT

This report describes how your pavement maintenance management program was developed. This program was developed as part of the Network Pavement Management Program project sponsored by the Idaho Transportation Department, Division of Aeronautics. The information and data contained in this report ensures you are in compliance with the requirements of Federal Aviation Administration (FAA) Grant Assurance Number 11 which states that any airport requesting federal funds for pavement improvement projects must have implemented a pavement maintenance management program (PMMP).

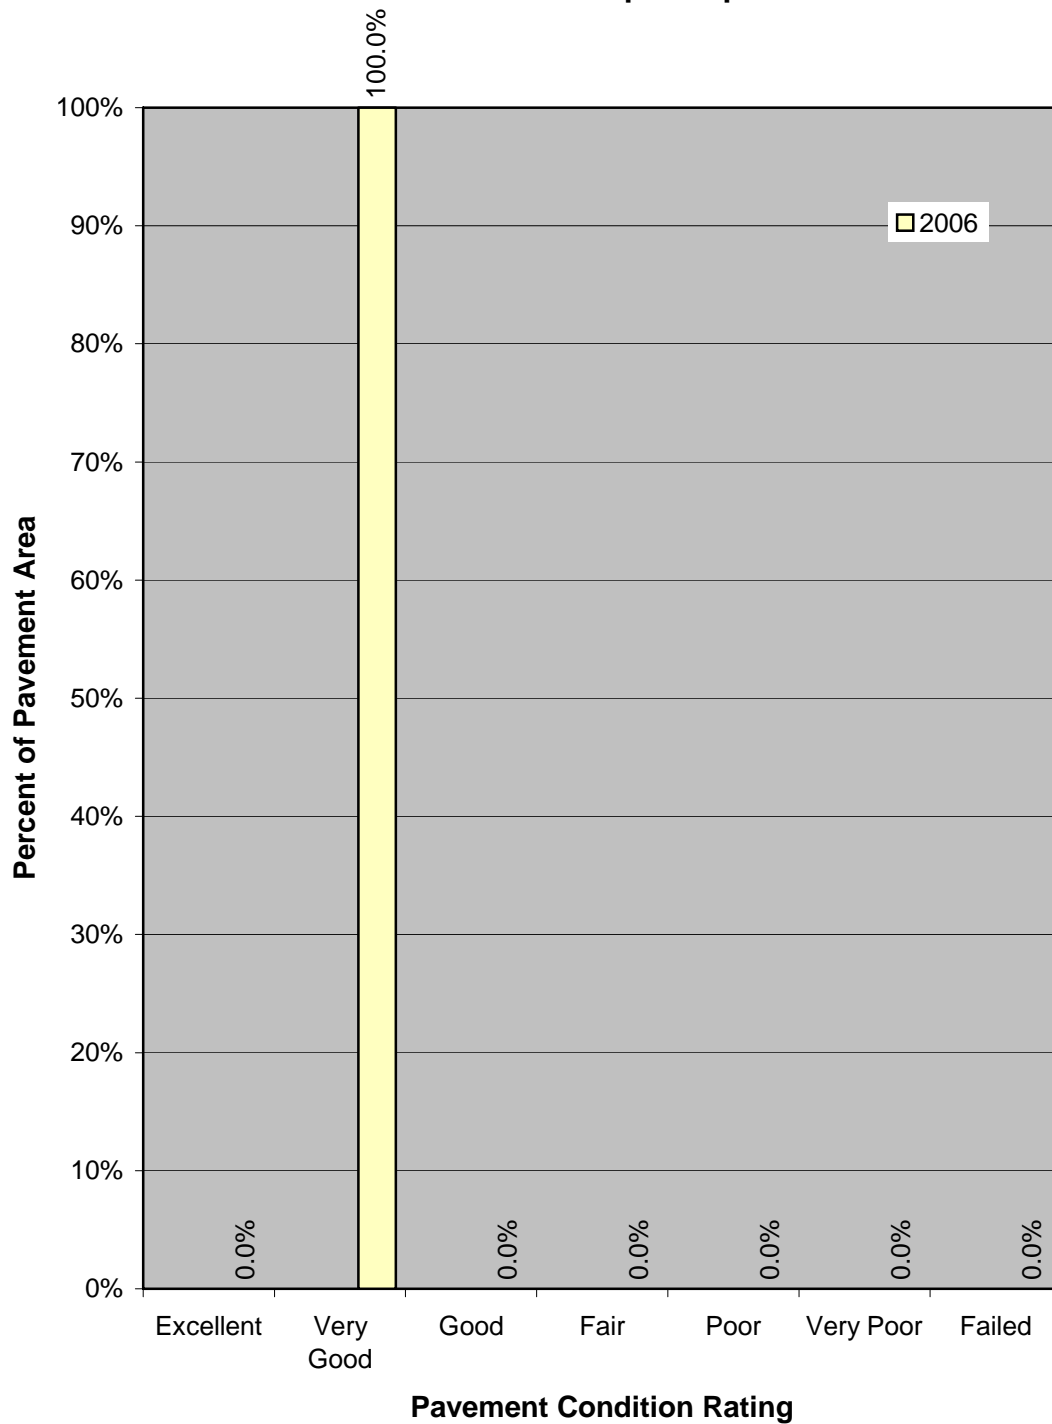
**Figure RF-4. Distribution of Pavement Condition
Rockford Municipal Airport**

Section PCIs at the airport range from a low of 80 (a PCR of “Very Good”) to a high of 80 (a PCR of “Very Good”). The area-weighted average PCI for all airport pavements is 80 corresponding to an overall PCR of “Very Good”. Figure RF-4 shows how much pavement area is associated with each Pavement Condition Rating category and also shows pavement condition distribution for the inspection conducted in 2006. A graphical representation of the projected PCRs presented in Table RF-2 is shown in Figure RF-5.

The primary distress observed during the inspection was weathering/raveling.
